Nonlinear Whirl Response of a High-Speed Seal Test Rotor With Marginal and Extended Squeeze-Film Dampers

Margaret P. Proctor
Glenn Research Center, Cleveland, Ohio

Edgar J. Gunter
RODYN Vibration Analysis, Inc., Charlottesville, Virginia

Prepared for the
Third Biennial International Symposium on Stability Control of Rotating
Machinery (ISCORMA-3)
sponsored by the Bently Pressurized Bearing Company
Cleveland, Ohio, September 19–23, 2005

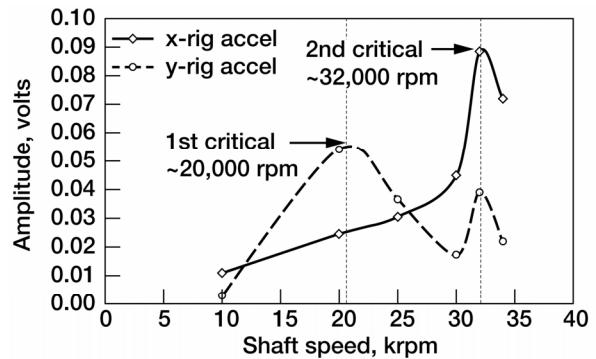
Figure 2 represents the seal test rig synchronous x and y accelerometer versus speed to 34,000 rpm. An apparent vertical resonant mode is observed at 20,000 rpm. A much stronger resonance mode for the X accelerometer occurs at 32,000 rpm. The difference between the vertical and horizontal accelerometer readings is due to the differences in bearing and support horizontal and vertical stiffness and damping values for the two planes. This asymmetric effect is often observed in un-centered dampers with moderate unbalance. Figure 3 shows the synchronous vertical turbine accelerometer amplitude as rotor speed increases. Above 32,000 rpm, a rapid increase in the turbine synchronous response measurement is observed. Also, fractional frequency whirl motion was observed in the turbine orbits at higher speeds. A further increase in the seal test rotor speed to its design speed of 43,140 rpm could have resulted in rig damage.

Fig. 2. x-y seal rig synchronous accelerometer amplitudes versus speed.

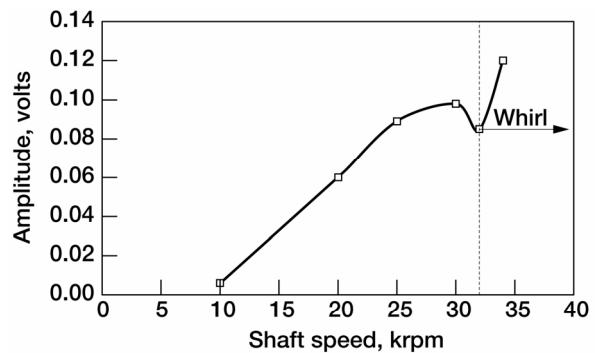
Fig. 3. Turbine y synchronous accelerometer amplitude versus speed shows unstable turbine motion above 32,000 rpm.

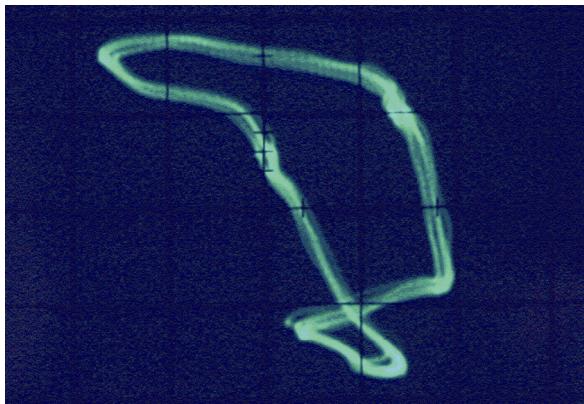
Figure 4 is an orbit obtained from the seal disk. Note the occurrence of the double loop. Sub-harmonics of one-half and one-third and super-harmonics have been observed. This could be an indication of rubbing. Figure 5 shows a time exposure of the seal test disk motion. The orbital motion indicates impeller whirling. Above 32,000 rpm, the whirl motion increases.

Fig. 4. Seal test rotor orbit at mid-span between the bearings has double loop at approximately 32,544 rpm.

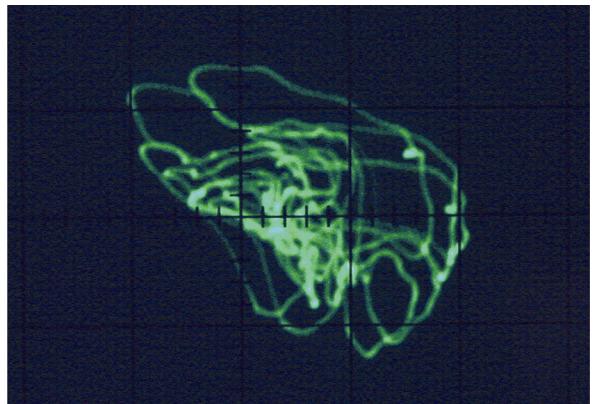
Fig. 5. Seal test rotor orbit at mid-span between the bearings shows non-synchronous whirling at approximately 32,544 rpm.

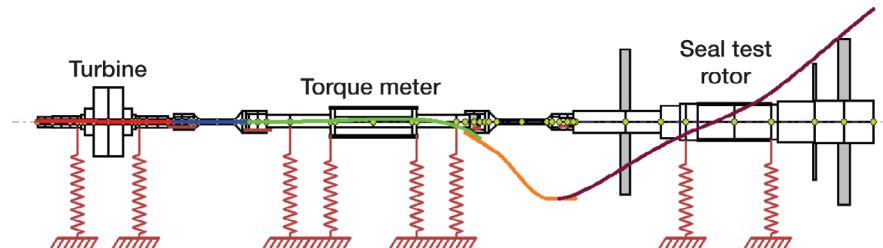
Fig. 6. Seal test rig first critical speed at 21,113 rpm shows conical motion of seal test rotor.

As a first step in evaluating the dynamic characteristics of the seal test rig, a model was generated of the entire system including the seal test rotor, drive turbine, torque meter, and spline shafts. Since high vibrations were also encountered at the seal test rotor drive end spline, it was important to determine if the drive system could be a contributing factor. With nominal bearing values selected, the system first undamped critical speed at 21,113 rpm shows the seal test rotor has a conical mode shape as shown in figure 6. Note that figure 2 shows a horizontal resonance around 20,000 rpm. This mode could be a conical whirling of the seal test rotor. With the conical motion, the bearing amplitudes are large and hence high damping should be provided in this mode.

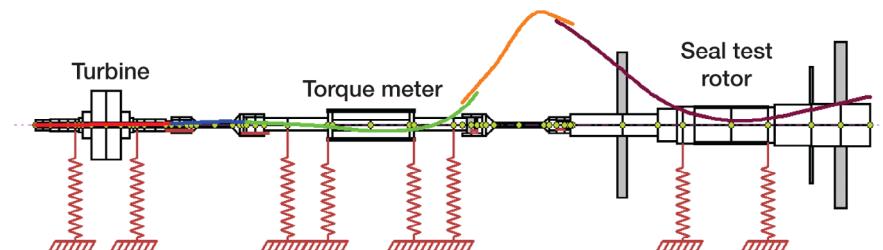
Fig. 7. Seal test rig second critical speed at 33,500 rpm shows high drive spline motion with balance piston and seal test disk in phase.

Figure 7 represents the system second critical speed mode at approximately 33,000 rpm. This high amplitude motion at the drive spline could cause the spline to become disconnected. In the second mode, there is more strain energy in bending than in the first mode. The majority of the strain energy for the first mode is in the test rotor bearings. From an examination of the system strain and kinetic energies, it is noted that the first two system modes are related to the seal test rotor and the drive components may be ignored.

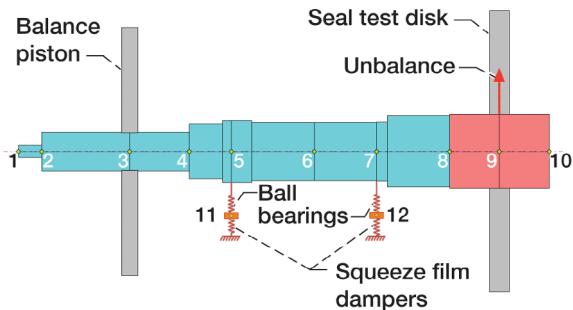
Figure 8 represents a model of the seal test rotor. The un-centered squeeze film dampers used to support the ball bearings are highly nonlinear. However, it is still of value to evaluate the rotor undamped critical speeds in order to determine the rotor mode shapes and the corresponding energy distribution for each mode.

Fig. 8. Model of seal test rotor with squeeze film dampers.

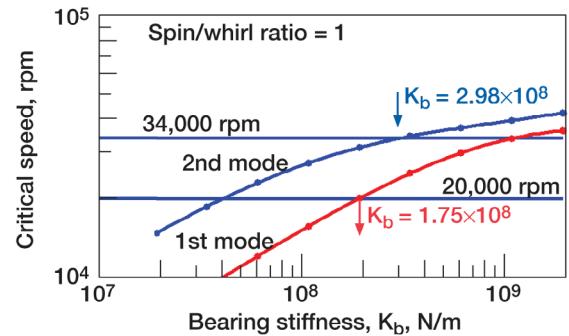
Figure 9 represents critical speeds for the seal test rotor for the first two modes as a function of bearing stiffness. On the critical speed map are drawn the speed lines for 20,000 and 34,000 rpm. With a nominal bearing stiffness value of 175 MN/m, the first critical speed is predicted to be 20,000 rpm. This corresponds to the first frequency as seen in figure 2. As the speed increases, the bearing stiffness increases with loading. The second critical speed is predicted to be 34,000 rpm for an assumed bearing stiffness of 298 MN/m as shown in figure 9.

Fig. 9. Critical speed map of seal test rotor with linear bearings.

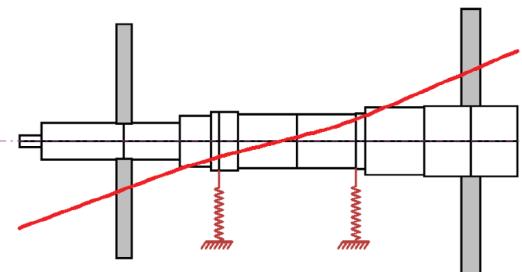
Figure 10 shows that the first mode is essentially a conical rigid body mode with the seal impeller and the balance piston out of phase. Figure 11 represents the bearing and shaft relative potential or strain energy for this mode. Only 19 percent of the energy is in shaft bending. This also implies that two plane balancing will be sufficient to balance this mode. The test-end bearing contains over 50 percent of the system strain energy and has a major influence on the first critical speed. At higher shaft speeds, this bearing will be the principal bearing that must be modified to control sub-synchronous whirling.

Fig. 10. First mode shape at 20,088 rpm with $K_b = 175$ MN/m.

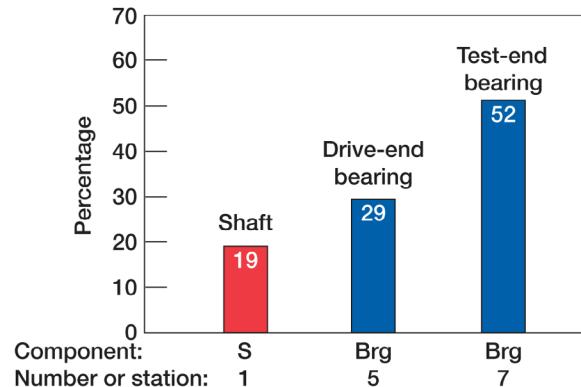
Fig. 11. First mode potential energy distribution.

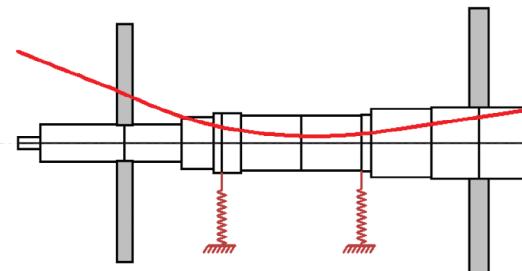
Figure 12 represents the second critical speed mode shape at 31,291 rpm for an assumed bearing stiffness of 175 MN/m. Figure 13 shows the second mode potential energy distribution, which indicates that the test-end damper has little control on the second critical speed. To control the second critical speed and high amplitude observed at the spline, the drive-end bearing must be modified.

Fig. 12. Second mode shape at 31,291 rpm with $K_b = 175$ MN/m.

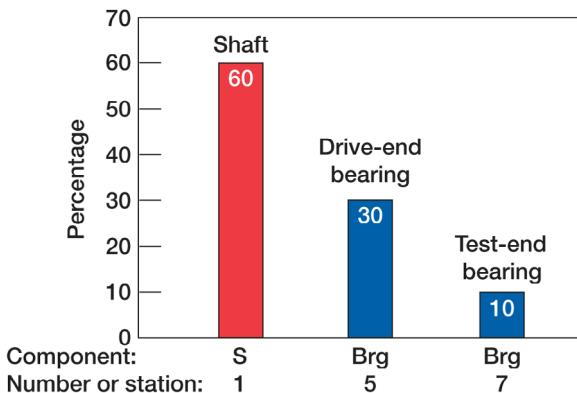
Fig. 13. Second mode potential energy distribution.

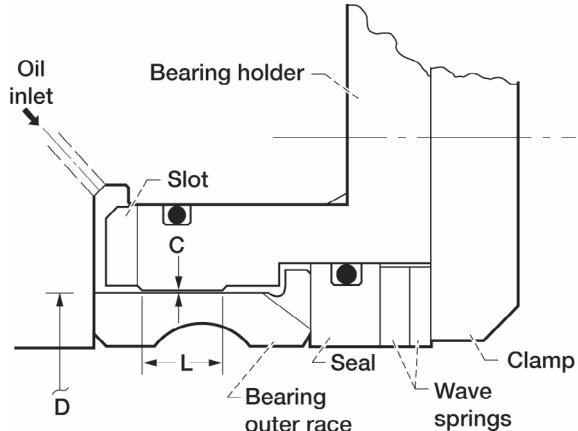
Fig. 14. Test-end damper bearing.

The unbalance response of the seal test rotor with the rolling element bearings mounted in squeeze film dampers is highly nonlinear in nature. The squeeze-film dampers are formed by the geometry of the bearing holder and the outer race of the bearing. The test end squeeze film damper, figure 14, is formed at 7.37-cm diameter, D , has a length, L , of 5.84 mm, and has a radial clearance, C , of 0.051 mm. MIL-23699 oil is supplied to the damper through three oil inlets. The slot in the left end of the bearing holder provides a route for thermocouple wires that measure the bearing outer race temperature. There is no path for the oil to exit the test-end squeeze film damper. The drive-end squeeze film damper has the same dimensions and is mounted in a similar fashion, except that oil can flow through it.

The damper is referred to as an un-centered squeeze film damper since it does not have a mechanical centering spring. The damper design is similar to that encountered in various HP aircraft gas turbine rotors. Therefore, the damper design and test results have significance towards design of damper bearings for various aircraft engine components.

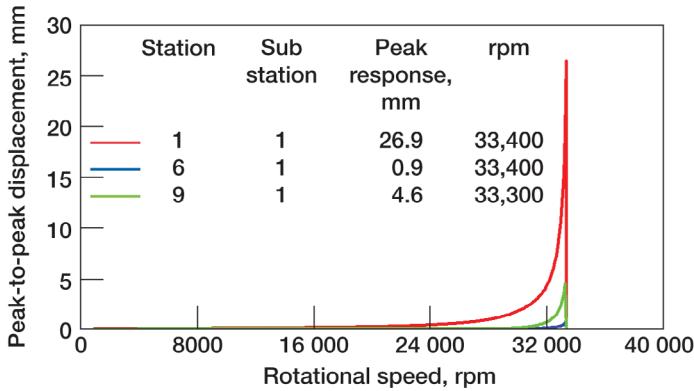
Fig. 15. Unbalance response with original damper design showing rotor failure with 0.360 kg-mm unbalance at the seal test disk.

An unbalance response was computed with the original length dampers of 5.84 mm inches and a 0.051 mm radial clearance. Figure 15 represents the unbalance response with the nonlinear stiffness and damping coefficients as given in equations (1) and (2). An unbalance of 0.360 kg-mm is applied at the seal test disk, station 9. The rotor displacement at the spline, mid-span of bearings, and seal test disk (stations 1, 6, and 9, respectively) is shown versus rotational speed. The synchronous unbalance response increases rapidly at speeds above 33,000 rpm. Any attempt to increase rotor speed beyond the 33,000 rpm could damage the seal test rotor. Figure 16 shows the three-dimensional mode shape at 33,000 rpm. The rotor rotating mode shape corresponds closely to the second mode as shown in figure 12. Note in the unbalance response mode shape that the bearings are bottomed out. Since there is high eccentricity at the damper bearings, they contribute no damping. Thus, when the squeeze film damper bearings bottom out or lock up, it is not possible to safely pass through the higher critical speed.

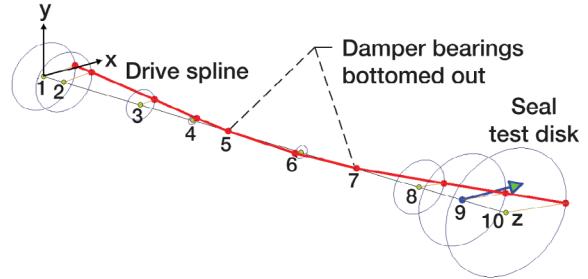
Fig. 16. Rotor unbalance mode shape at 33,000 rpm shows damper lockup.

This condition is referred to as damper lockup and is equivalent to dead band whirl in a rolling element bearing. High bearing forces occur under these circumstances.

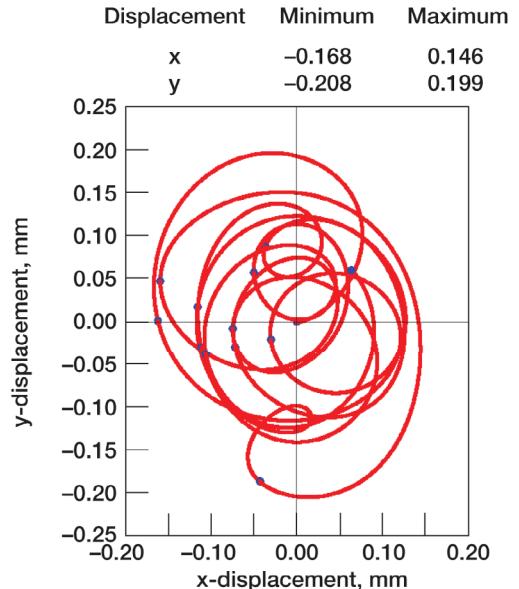
Figure 18 shows the transient motion of the seal test disk with a suddenly applied unbalance and an assumed value of aerodynamic cross coupling coefficient of $Q = 876$ kN/m. This Alford type effect is created by assuming a bearing station at the seal test disk and assigning $K_{xy} = K_{yx} = Q$. The seal test disk orbit shown in figure 18 indicates that the system is sensitive to small cross coupling forces that could be generated in typical seals. Figure 18 also indicates that the maximum orbit may exceed 0.2 mm. This could also lead to seal rubs

Fig. 18. Seal test disk orbit with original dampers, unbalance, $U_b = 0.360$ kg-mm, and cross coupling, $Q = 876$ kN/m, at 35,000 rpm. $L = 5.84$ mm.

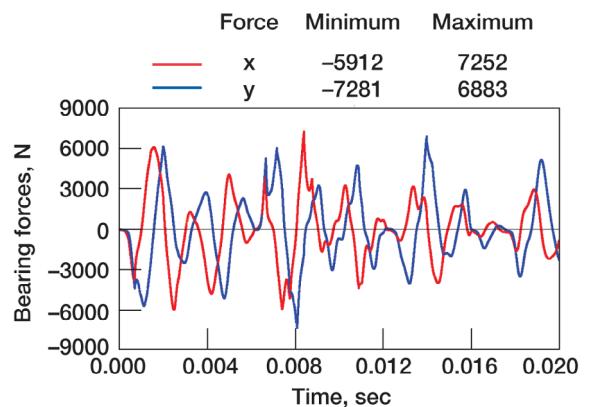
Fig. 19. Test-end damper bearing transient forces at 35,000 rpm. $L = 5.84$ mm, $U_b = 0.360$ kg-mm at seal test disk.

Figure 19 shows the transient test-end damper bearing forces transmitted. These bearing loads are excessive and can result in diminished rolling element bearing life. There is a low frequency component in bearing forces, which indicates whirling. The bearing loading is similar to the loads encountered with a rolling element bearing undergoing dead band whirl with a 0.051 mm clearance. It is apparent from the unbalance response plot of figure 15 and the whirl orbit shown in figure 18 that the dampers are insufficient to provide adequate damping for control of seal test disk whirling or for control of the high amplitude of vibration encountered at the drive spline at the second critical speed.

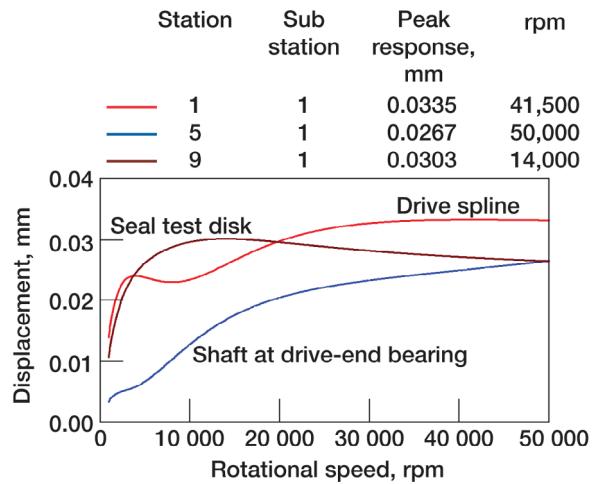
An analysis was performed with enhanced dampers in which the damper length increased from 5.84 to 12.7 mm. Figure 20 represents the unbalance response with the enhanced dampers and two planes of unbalance of 0.072 kg-mm at 90° relative phase as shown in figure 21. With the increased damping and the reduced level of unbalance, the response is smooth to 50,000 rpm. Figure 21 represents the synchronous mode shape at 45,000 rpm. The rotor has little bending.

Fig. 20. Unbalance response with enhanced dampers and 90 degree out-of-phase unbalance of 0.072 kg-mm at seal test disk and balance piston.

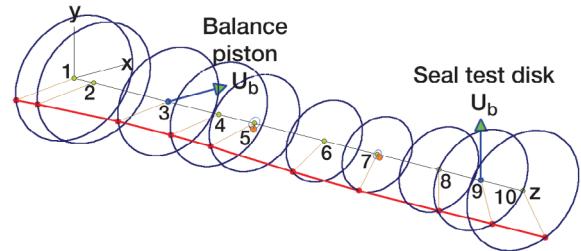
Fig. 21. Rotor mode shape at 45,000 rpm. $L = 12.7$ mm, $U_b = 0.072$ kg-mm, $Q = 876$ kN/m.

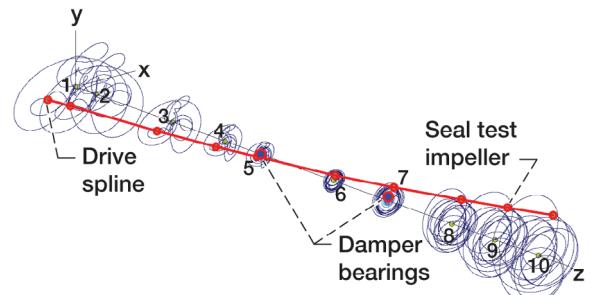
Figure 22 shows the transient response of the seal test rotor at 35,000 rpm with two planes of unbalance and aerodynamic cross-coupling. Note the conical shaft motion with active damper motion. Figure 23 represents the test-end bearing forces transmitted. The initial first forward conical mode rapidly damps out leaving only the synchronous unbalance response. There is no indication of self excited whirl motion present in the transient analysis. Figure 24 represents the transient motion at 45,000 rpm. The motion is stable limit cycle whirl.

Fig. 22. Transient seal test rotor motion at 35,000 rpm with enhanced squeeze film dampers, $L = 12.7$ mm, $U_b = 0.072$ kg-mm at balance piston and seal test disk, $Q = 876$ kN-m.

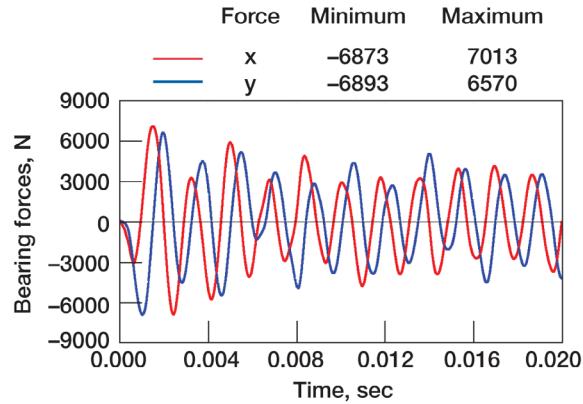
Fig. 23. Test-end bearing forces with enhanced squeeze film dampers at 35,000 rpm; $L = 12.7$ mm, $U_b = 0.072$ kg-mm at seal test disk and balance piston.

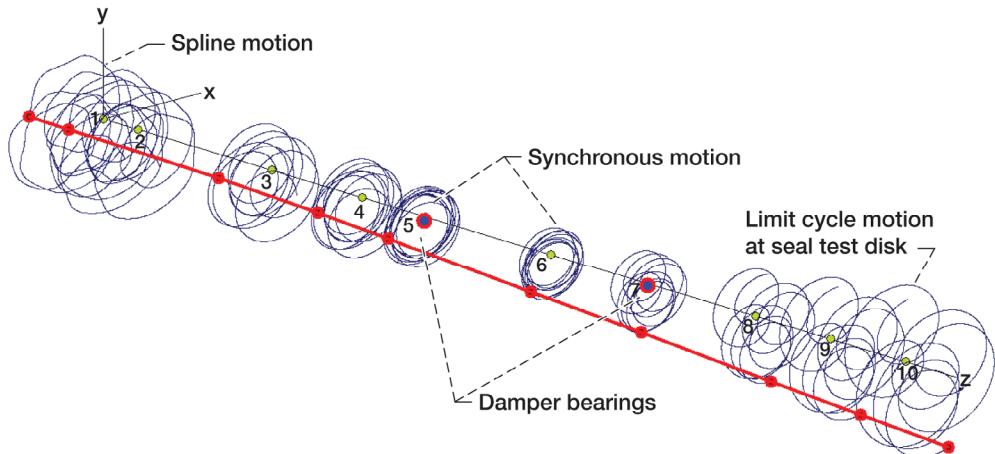
Fig. 24. Transient motion at 45,000 rpm showing stable limit cycle whirl motion with enhanced damper, $L = 12.7$ mm.

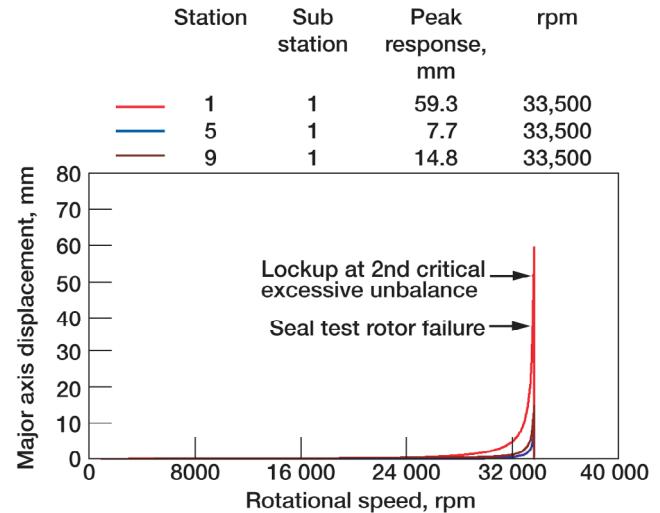
Figure 25 represents the nonlinear unbalance response if each of the two planes of unbalance are increased from 0.072 to 0.360 kg-mm. Damper lock up will occur at 33,600 rpm. Figure 26 shows the relative test-end damper motion at 30,000 rpm has high eccentricity, further verifying damper lock up.

Fig. 25. Synchronous response with enhanced dampers, $L = 12.7$ mm, high unbalance, $U_b = 0.360$ kg-mm 90 degree out-of-phase at balance piston and seal test disk.

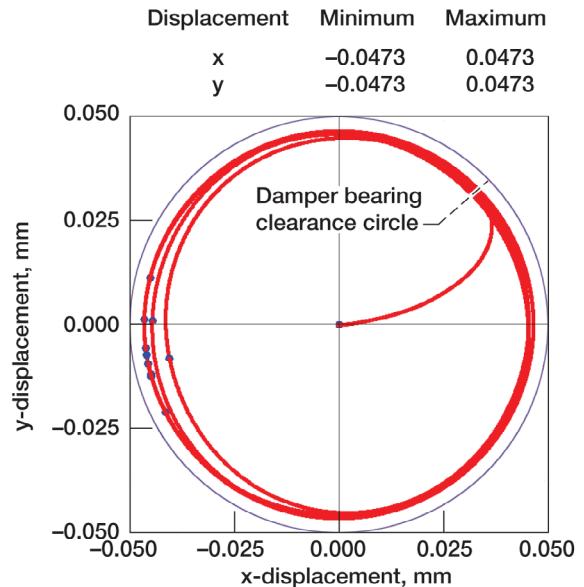
Fig. 26. Relative motion at test-end damper at 30,000 rpm showing high eccentricity; $L = 12.7$ mm, $U_b = 0.360$ kg-mm at balance piston and seal test disk, and $Q = 876$ kN/m.
